TWELVE MONTH PROGRESS REPORT NASA-NAG8-846

CHEMICAL COMPATIBILITY OF CARTRIDGE MATERIALS

R.C. Wilcox and R.H. Zee
Department of Mechanical Engineering
Auburn University, AL 36849-5341
Phone: (205) 844-3323
Fax: (205) 844-3307

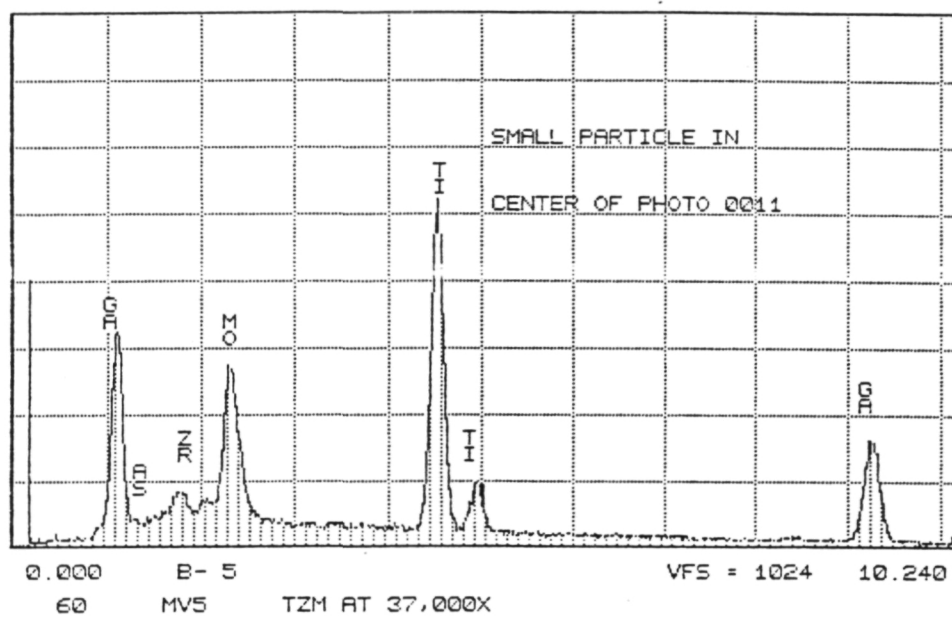
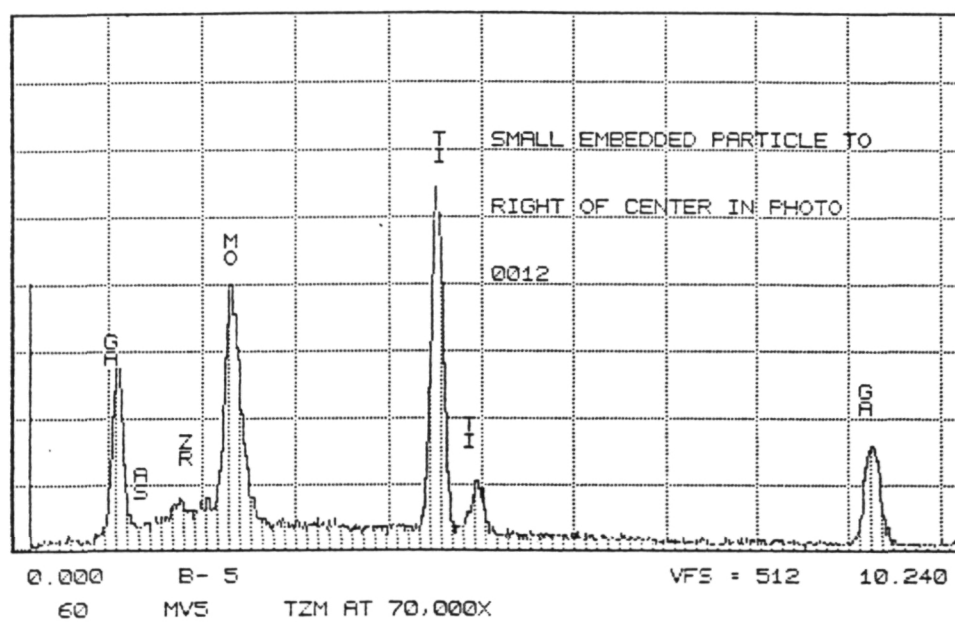
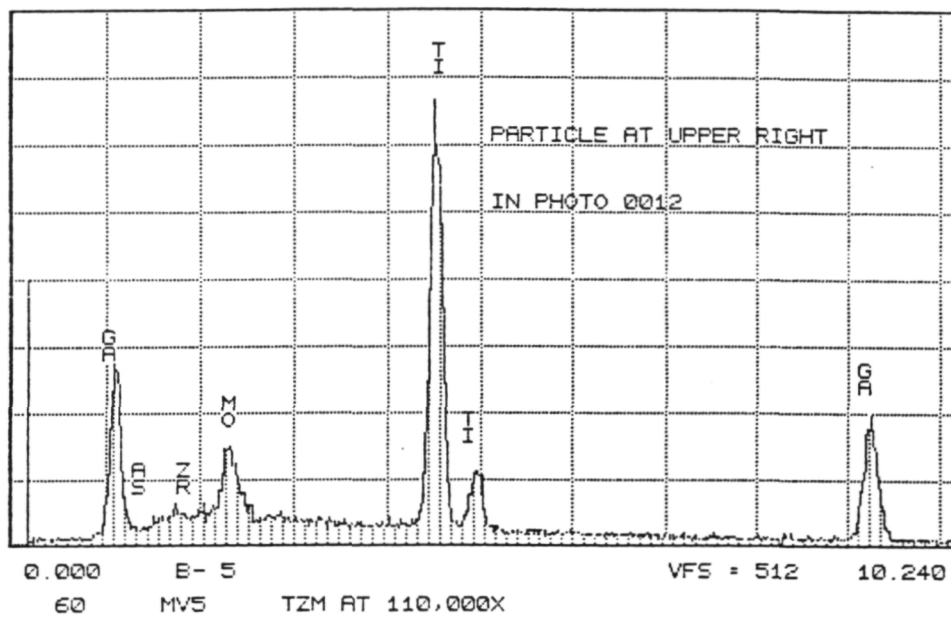
Figure 50. EDX spectrum from small particle in center of Figures 44 and 49.

Figure 51. EDX spectrum from small embedded particle to right center in Figure 49.

Figure 52. EDX spectrum from particle at upper right in Figure 49.

particles shown in Figure 49 are given in Figure 50, 51 and 52. All of the particles contained gallium and titanium. However, when x-ray analysis (Figure 53) was performed of the matrix (a grain) from the center of Figure 49 only a molybdenum peak was found.

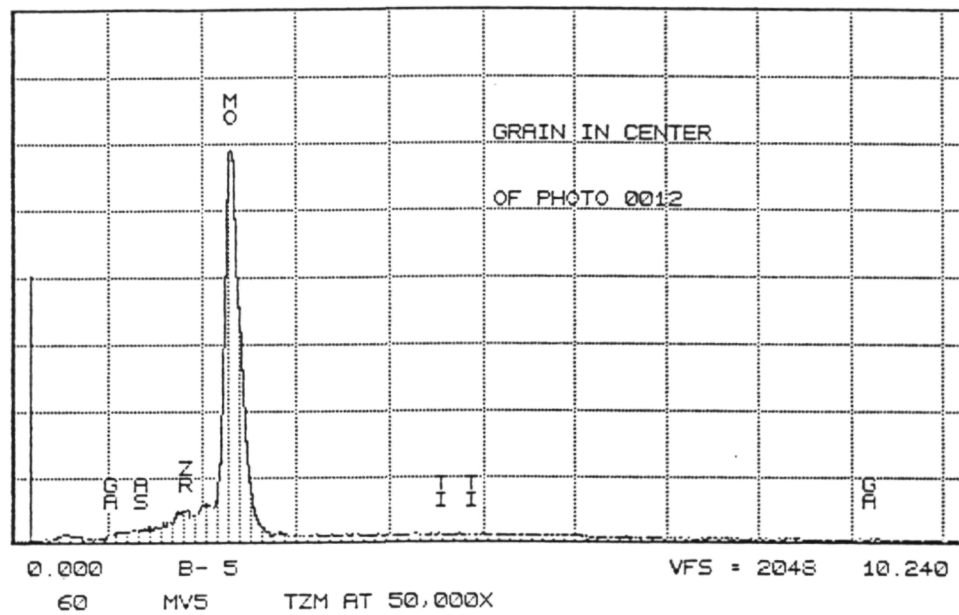
Figure 53. EDX spectrum from grain in center of Figure 49.

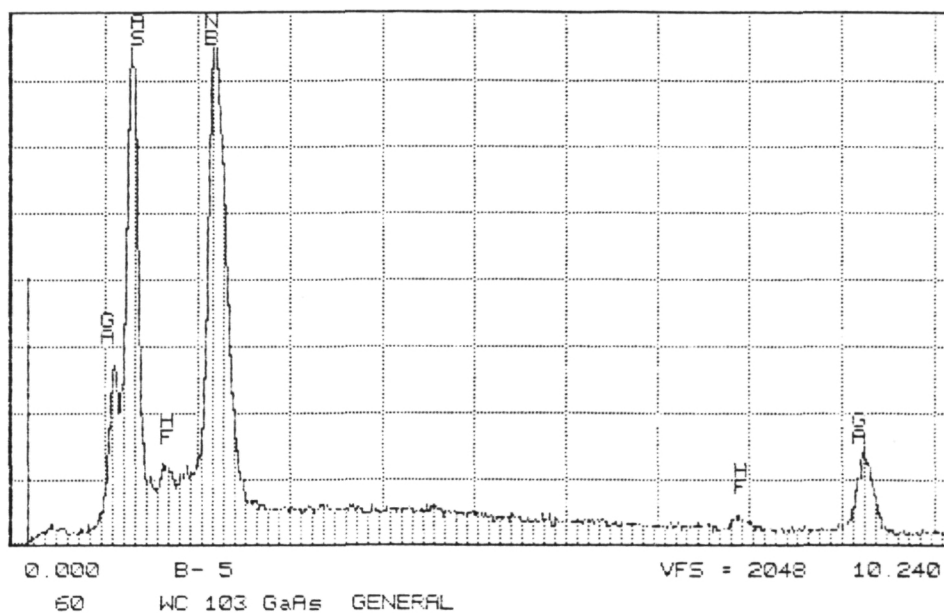
Figure 56. General EDX spectrum from surface of Wc 103 piece with GaAs.

The EDX spectrum taken from the center of the cross section of the reacted piece of WC 103 is shown in Figure 56. From this spectrum, it is evident that both gallium and arsenic are present at this point along with the alloying elements niobium, hafnium and at times titanium. Prior to the reaction the cross section of the piece of WC 103 used was rectangular. After the reaction, the cross section at best could be said to be oblong in shape with EXTREMELY rough and irregular surfaces. No place in this cross section was a gallium - arsenic free zone found. In fact, large particles of relatively pure gallium were found in some regions of the cross section. These results indicate that GaAs is very reactive with WC 103. It should be remembered that the compatibility test was performed in such a manner that the reaction occurred simultaneously on all surfaces of the piece of WC 103. To obtain a true picture of the reaction rate of GaAs with WC 103, a solid piece of WC 103 in which a hole could be drilled and the GaAs added to the hole so the reaction could occur only on one surface would be best.

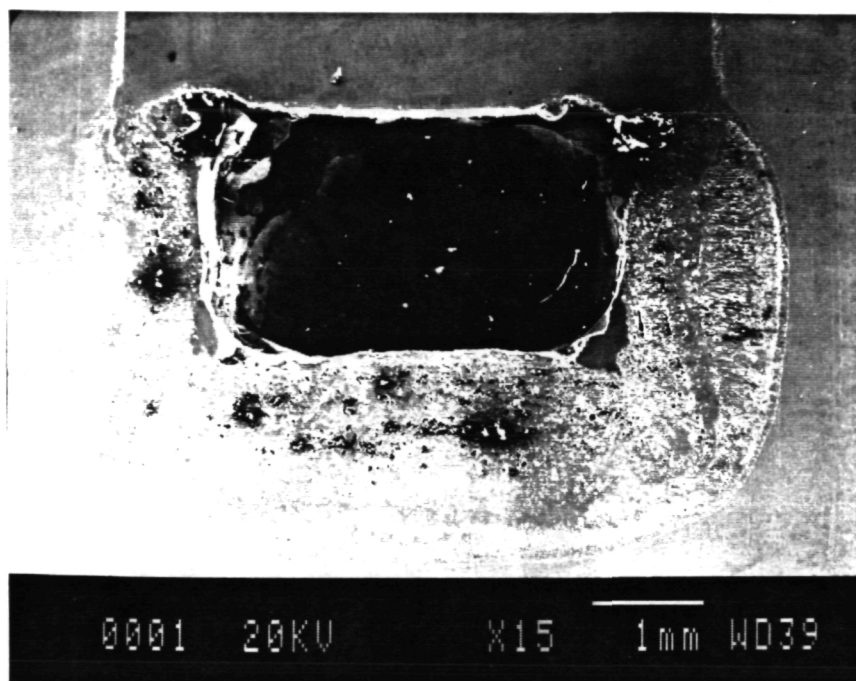
Figure 60. Reaction region between WC 103 and GaAs after 28.17 hr.

- #3 - Reaction Zone 0.27-0.53 mm
0.36 mm ave (Nb+Hf+As+little Ga)
- #4 - Reaction Zone 0.47-0.67 mm
0.53 mm ave (Nb+Hf+little more Ga
+ much less As)

- #5 - Base metal WC 103
- #6 - Reaction Zone 0.07 mm
(Nb+Hf+little Gs + no As)
